# **PRE-CERCLA SCREENING REPORT**

Dawson Metal Products Camdenton  
Facility #2 Site  
Camden County, Missouri

September 6, 2017

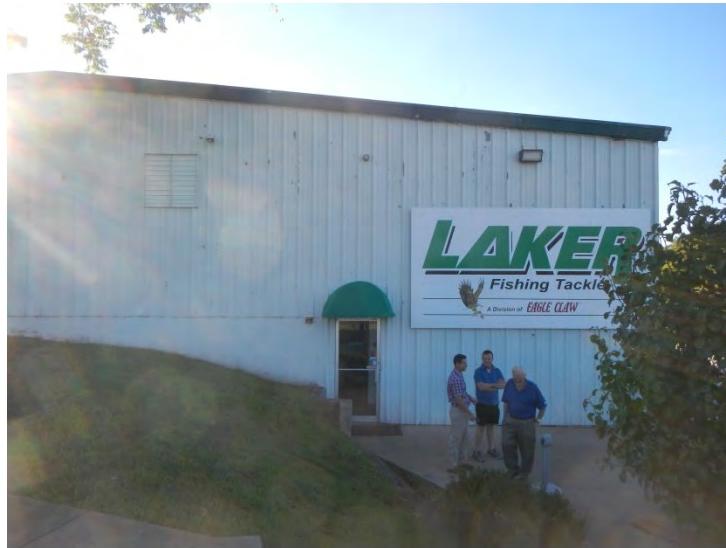
Photograph 1  
Dawson Metal Products  
Camdenton Facility #2 Site  
Camden County, MO  
Photo taken 8/23/17 by  
Amanda Branson,  
DEQ, HWP, SP

Front view of the Laker Fishing  
Tackle Facility.  
Photo taken towards the northwest.

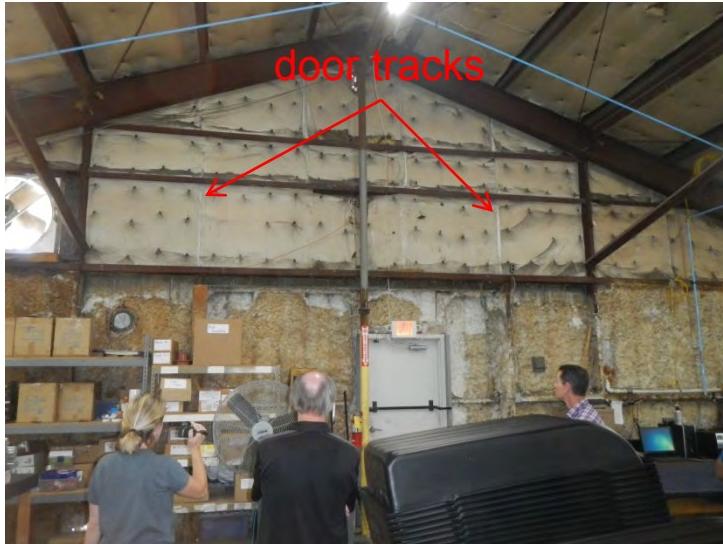
Photograph 2  
Dawson Metal Products  
Camdenton Facility #2 Site  
Camden County, MO  
Photo taken 8/23/17 by  
Amanda Branson,  
DEQ, HWP, SP

Former location of the shipping dock  
door. The overhead door that was  
present in 1972 is no longer present,  
however, you can still see the  
location of the door tracks.  
Photo taken towards the northwest.

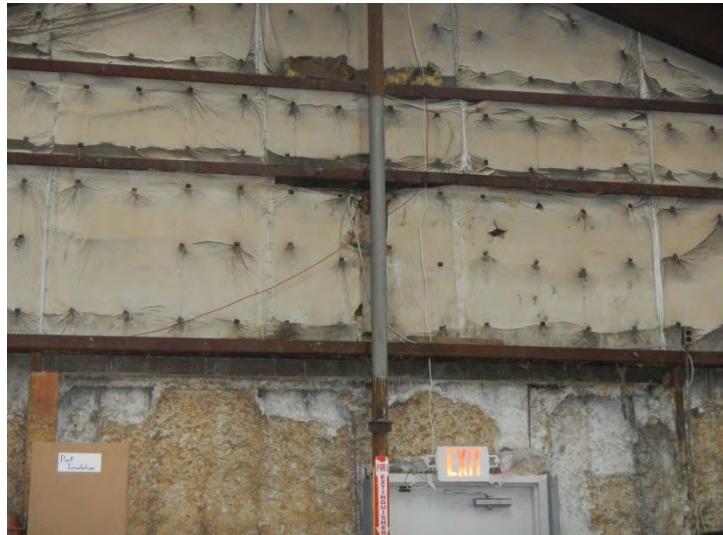
Photograph 3  
Dawson Metal Products  
Camdenton Facility #2 Site  
Camden County, MO  
Photo taken 8/23/17 by  
Amanda Branson,  
DEQ, HWP, SP

Zoomed in view of the former  
location of the shipping dock door.  
Photo taken towards the northwest.

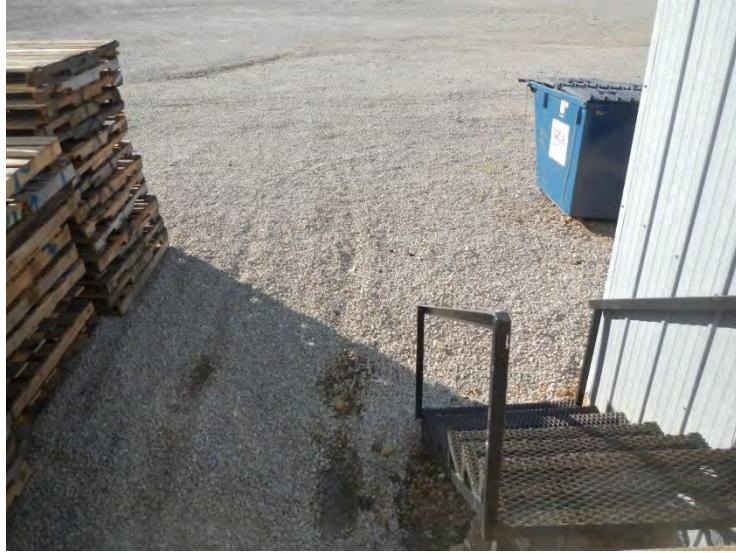
Photograph 4

Suspected area of TCE disposal  
off of the shipping dock.  
Photo taken facing the northwest  
looking down and off the  
shipping dock.

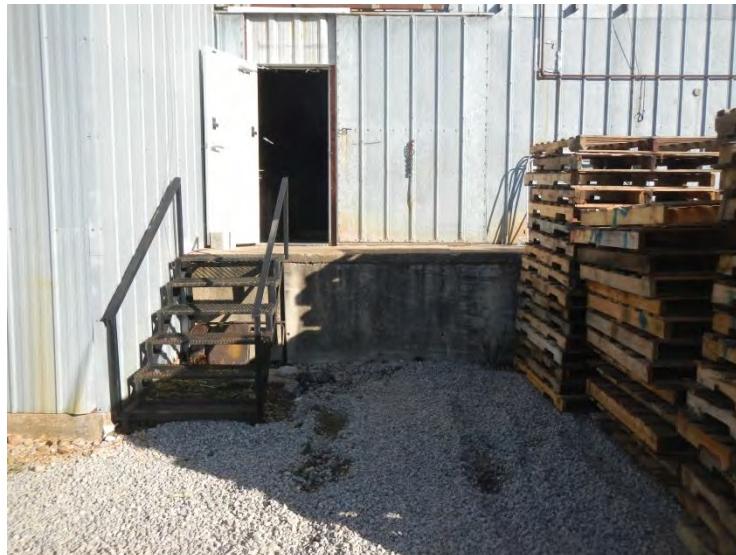
Dawson Metal Products  
Camdenton Facility #2 Site  
Camden County, MO  
Photo taken 8/23/17 by  
Amanda Branson,  
DEQ, HWP, SP

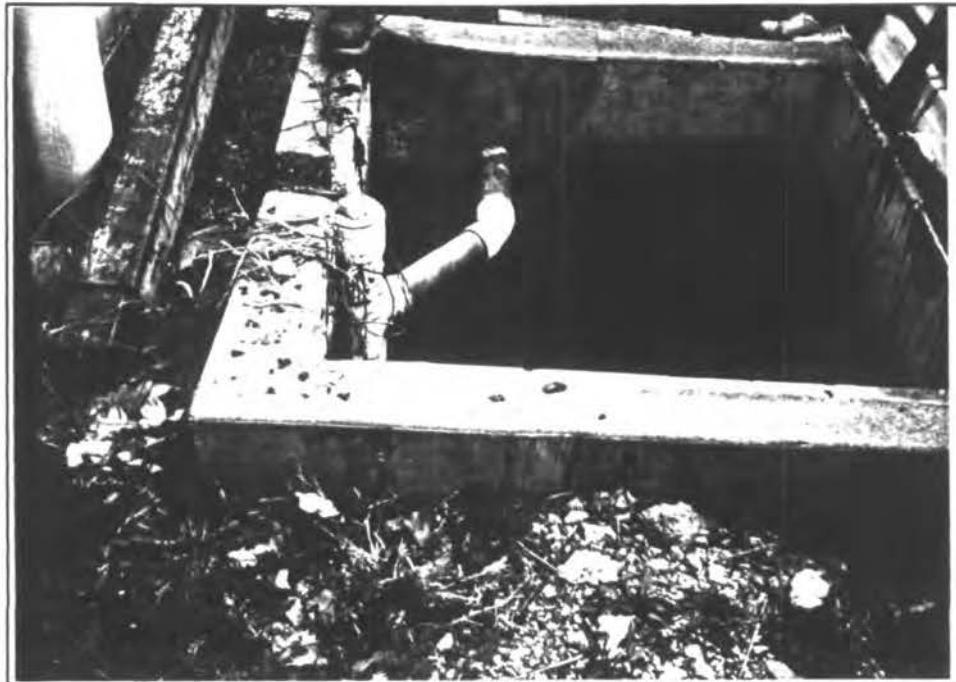
**PHOTOGRAPH NO. 3**

**Subject:** Mudpit drainage sump  
**Location:** SWMU #2

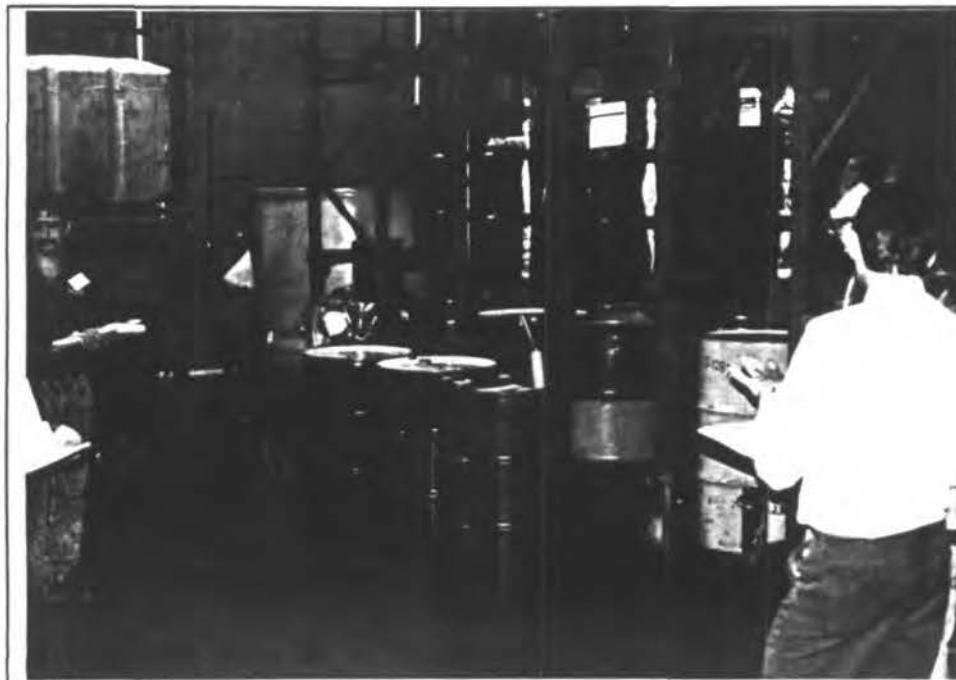
**PHOTOGRAPH NO. 4**

**Subject:** Pretreatment/Drum Storage Area  
**Location:** SWMU #3

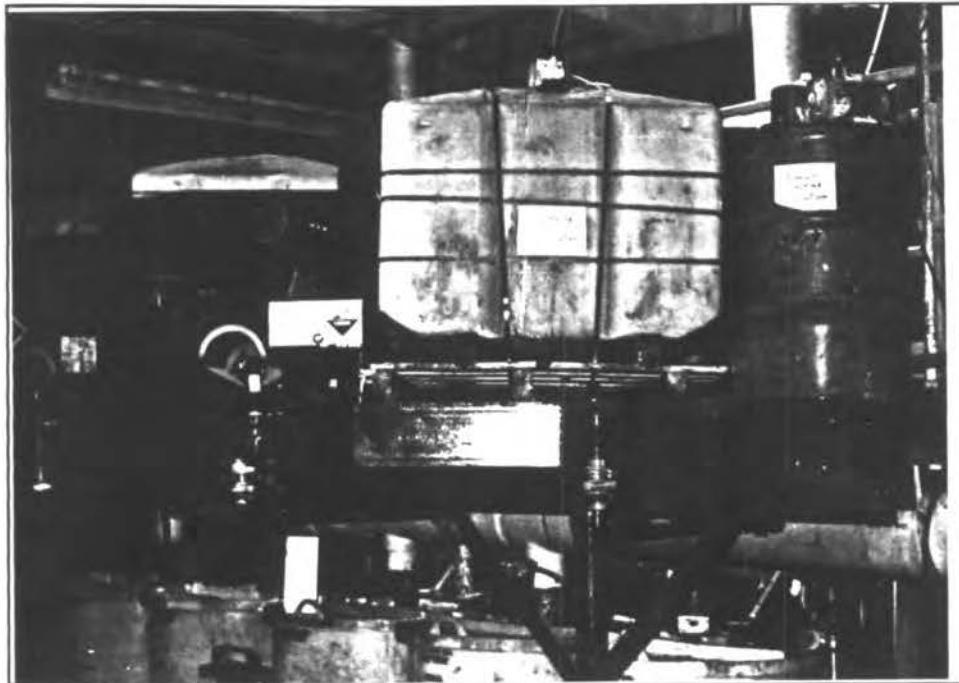
PHOTOGRAPH NO. 5

Subject: Pretreatment Wastewater System/Filter Press  
Location: SWMU #4

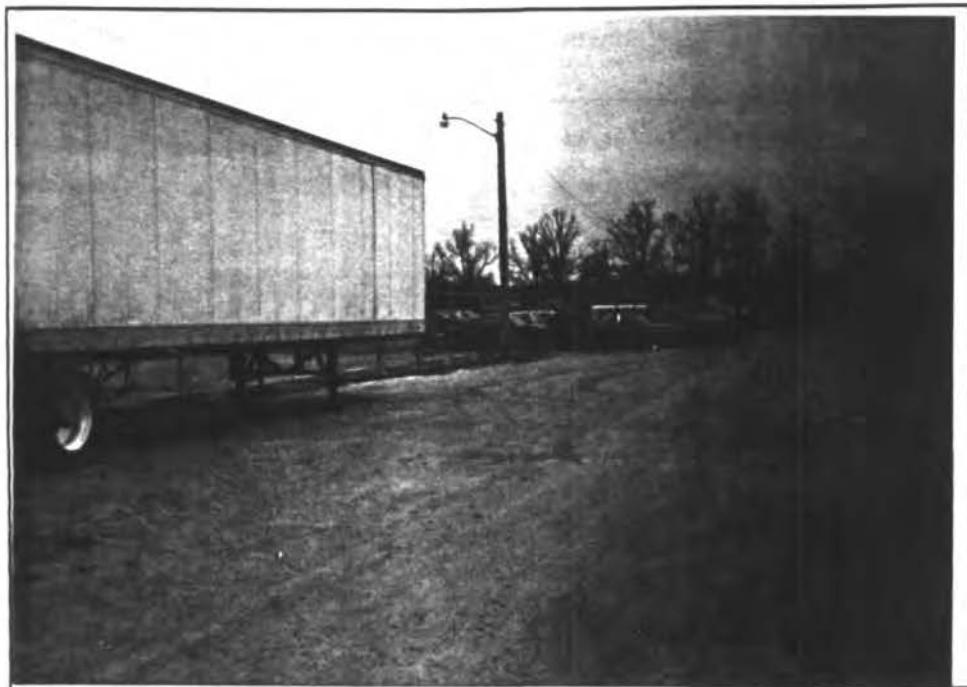
**PHOTOGRAPH NO. 7**

**Subject:** Drum Storage Area #1  
**Location:** SWMU #6

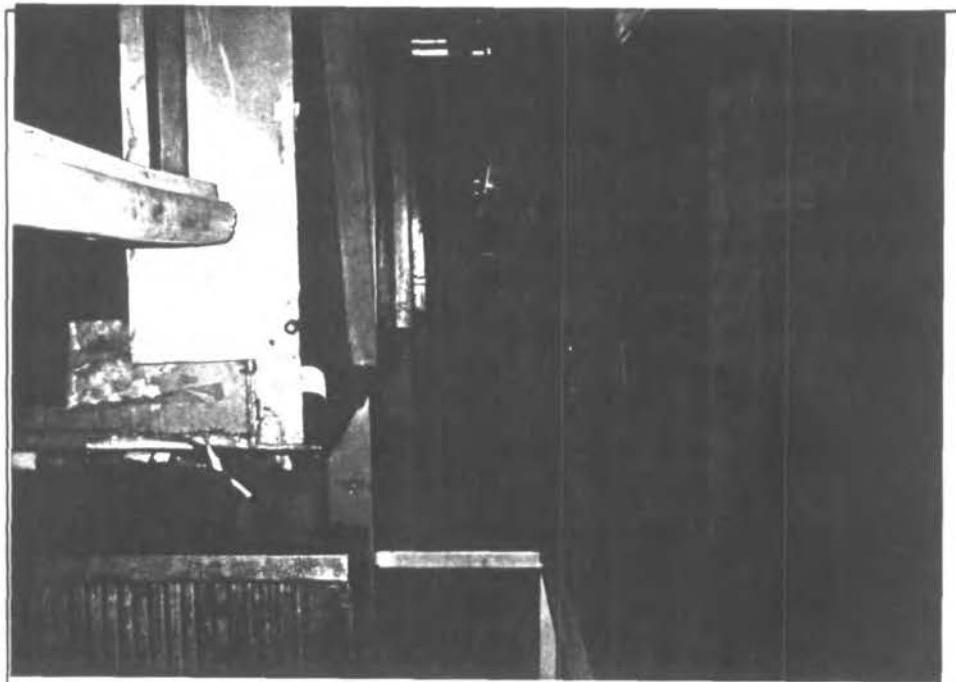
PHOTOGRAPH NO. 17

Subject: Two 2,000-Gallon Storage Tanks  
Location: SWMU #20

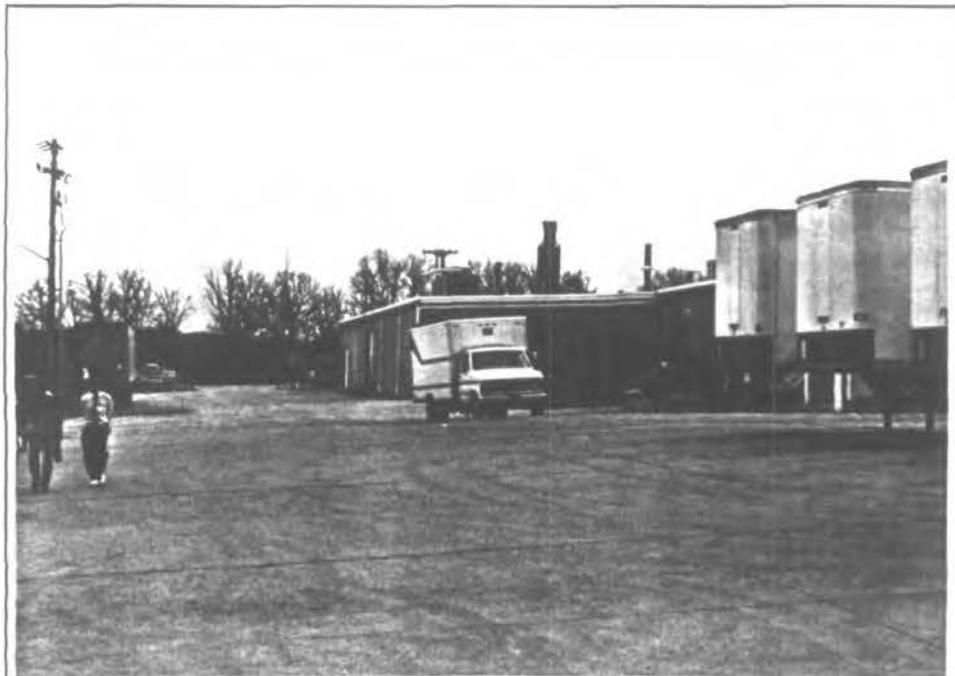
**PHOTOGRAPH NO. 20**

**Subject:** Scrap Metal Bins  
**Location:** SWMU #23 - between the truck and trailers
